HOME INSPECTION REPORT

Monday March 28, 2016

Baltimore Inspection Guy, LLC

mz2016004

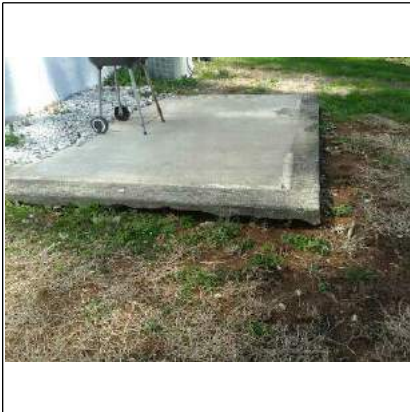
Comments Patio had some cracking and settlement, but was in usable condition. Recommend repair

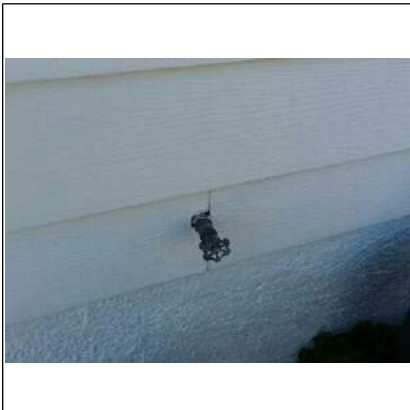
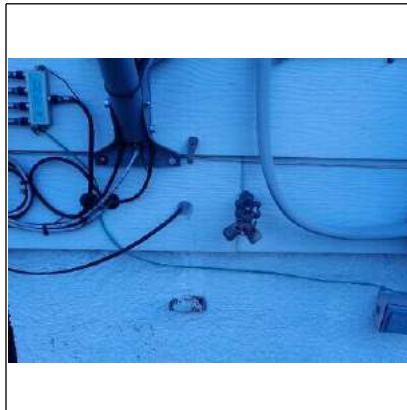
Comments Hose bib next to electric meter does not operate.

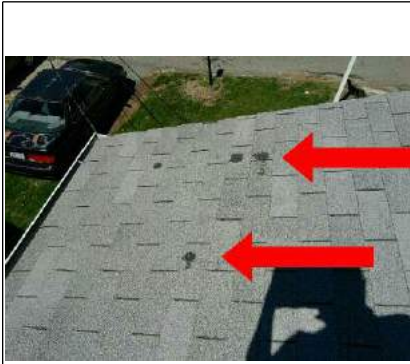
Comments Evidence of nail pops in shingles. Have been sealed with asphalt, recommend monitoring.

Evidence of repaired nail pops.
Recommend monitoring.

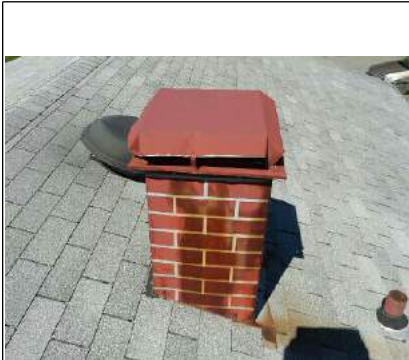
Surface corrosion evident on chimney chase.

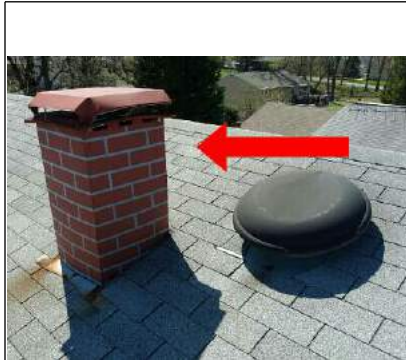
Chimney height is marginal. Recommend extending to a minimum of 2 feet above the roof ridge.

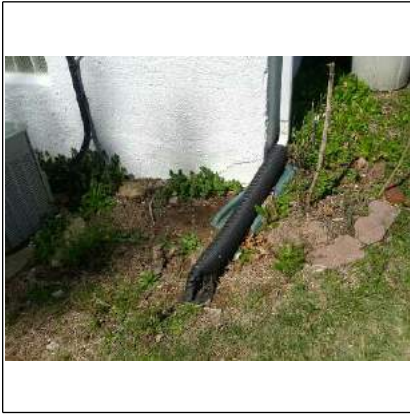
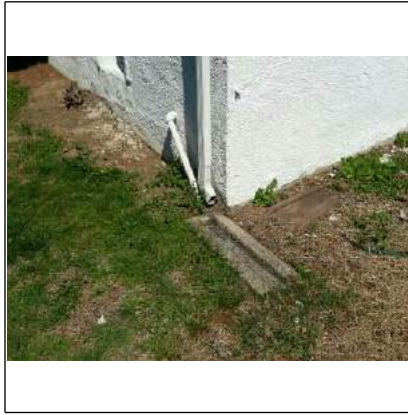
Comments Recommend maintaining downspout discharge a minimum of 5-6' away from the house. Downspouts had some visible damage , recommend repair

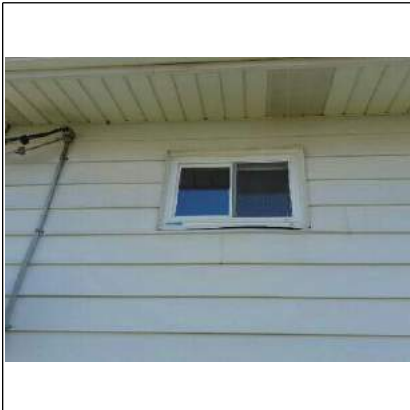
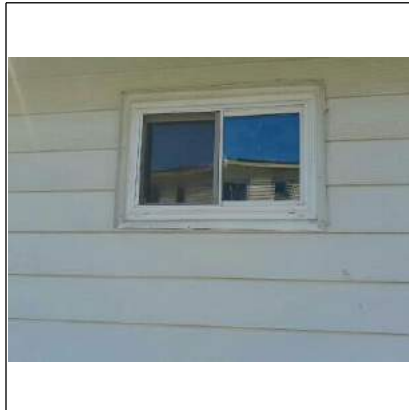
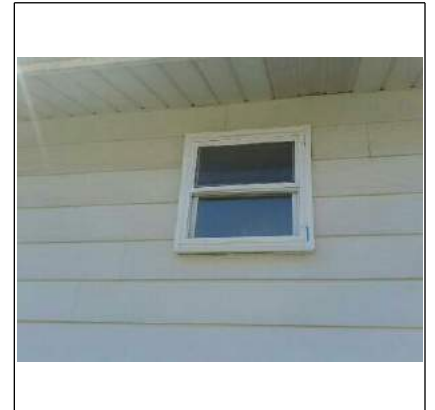
Comments Window sills/trim have some damage recommend repair/replacement

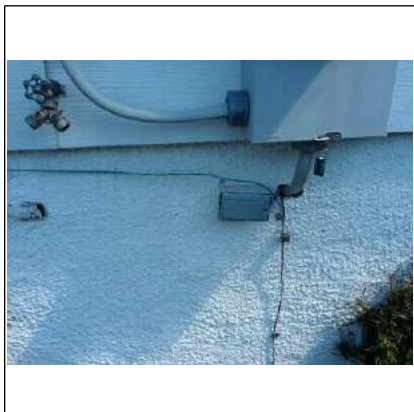
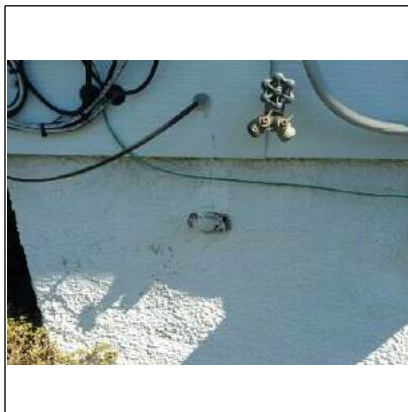
Comments GFCI box is loose, recommend fastening.

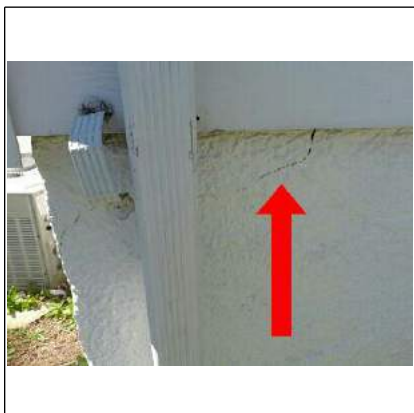
Type Not Visible Framed Masonry Other
Condition Not Visible Satisfactory Marginal Poor
Comments Crack in SE corner, recommend monitoring.

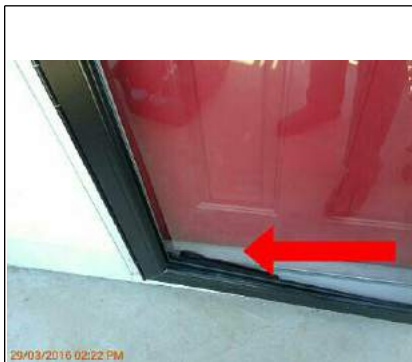
Comments Damage to front storm door, evidently from wind catching the door and slamming it into railing. Recommend repair.

Glass door insert has separated from frame. Recommend repair.

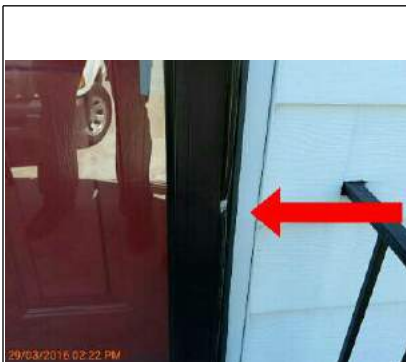
Glass door does not latch properly. Frame is damaged from wind slamming door into railing. Recommend repair.

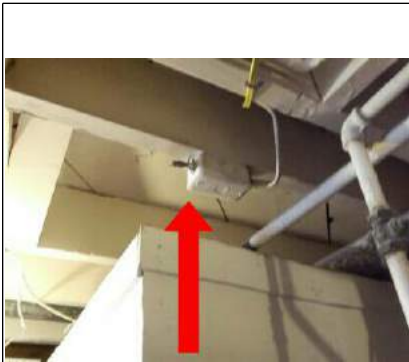
Exposed cut wire. Recommend electrician remove.

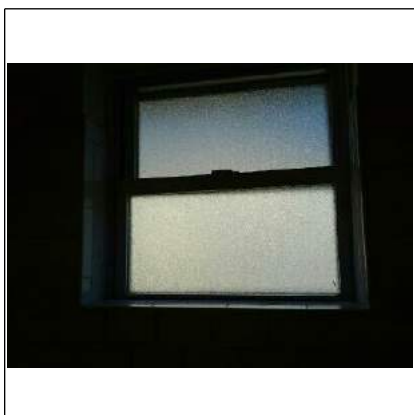
Comments Top window sash falls open when unmatched. Recommend repair.

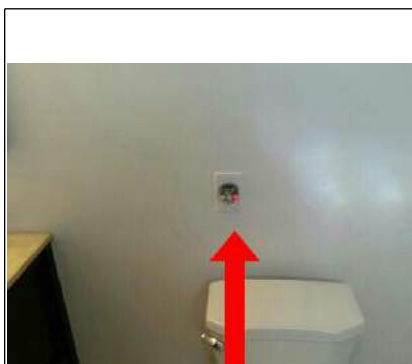
Open ground in this receptacle.
Recommend GFCI.

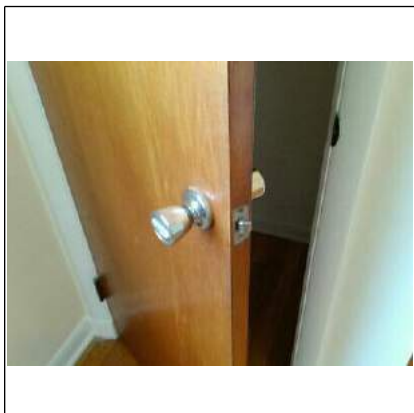
Comments Closet door knob installed backwards, recommend repair.

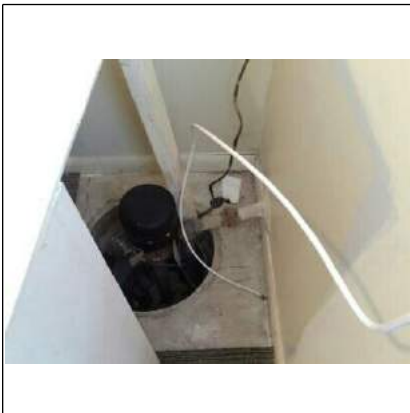
Furnace was not operating at time of inspection. Recommend HVAC technician evaluate.
Pedestal style sump pump in basement bedroom does not function. Recommend replacement.

Comments Non-operational pedestal type sump pump hidden under built in shelving. Recommend repair/ replace.

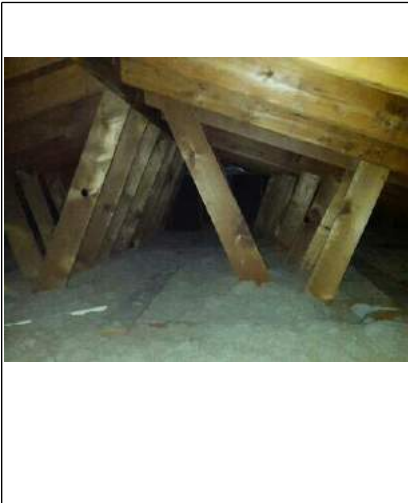
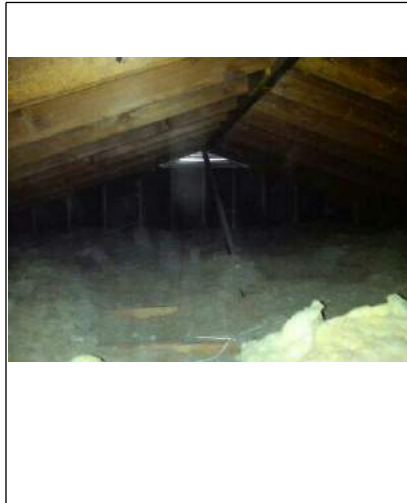
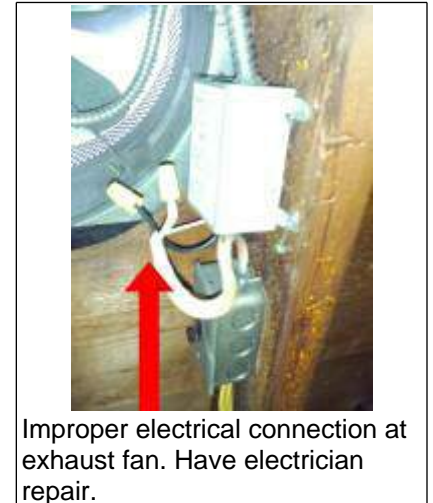
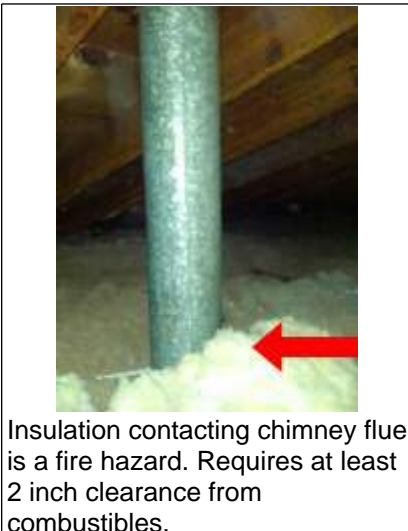
Comments Rafters appeared to be in overall adequate condition.
Insulation was average, but could be upgraded.
Vapor barrier not visible.

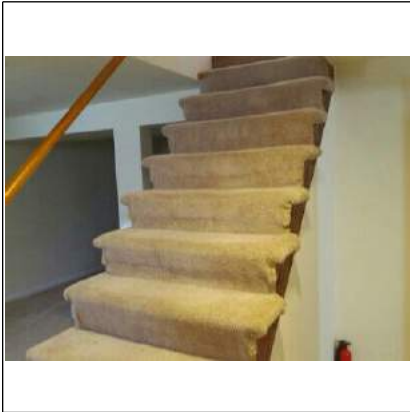
Comments Stair needs handrail on both sides.

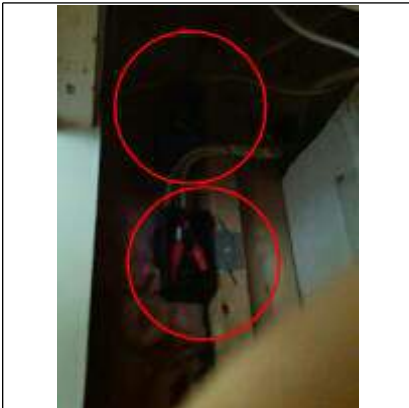
Open grounds and reverse polarity by water. Located in basement bath.
Open junction boxes - need cover plates. Located in closet with main electric panel.
Basement smoke detector does not operate. No carbon monoxide detector installed.

Open junction boxes, safety hazard, recommend covers

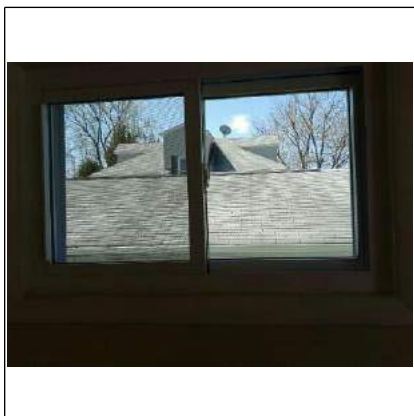
Comments Small window does not open properly.
