# HOME INSPECTION REPORT

**Inspection Date:**

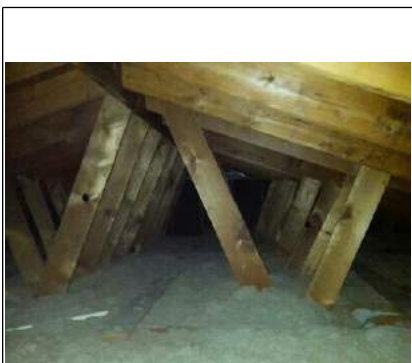
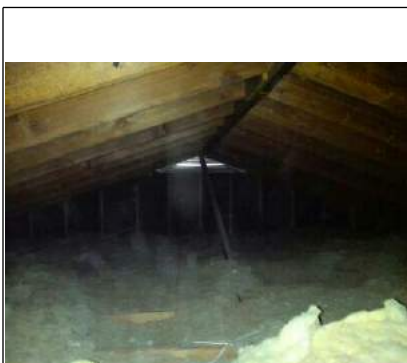
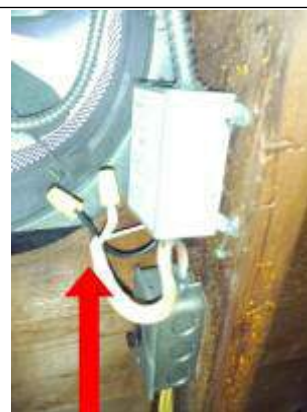
Improper electrical connection at exhaust fan. Have electrician repair.

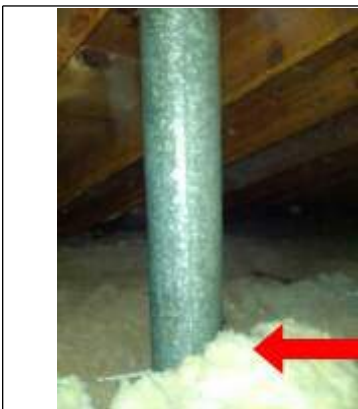
Insulation contacting chimney flue is a fire hazard. Requires at least 2 inch clearance from combustibles.
